## Dent Station Phase 6 Progress Photos May/June 2024

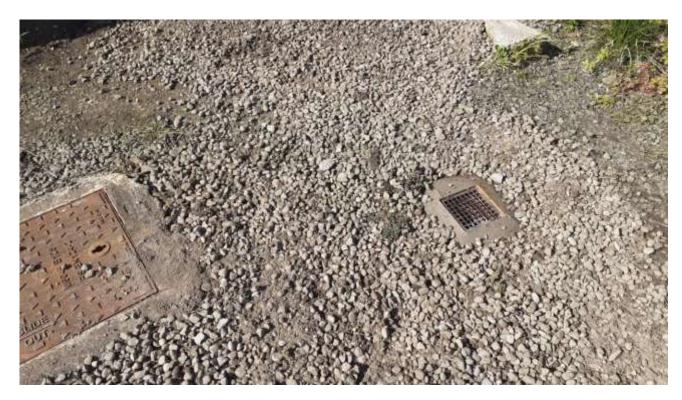
Manhole now drained.
