## Dent Station Works Progress May / June 2023

Works Started Thursday 11<sup>th</sup> May.

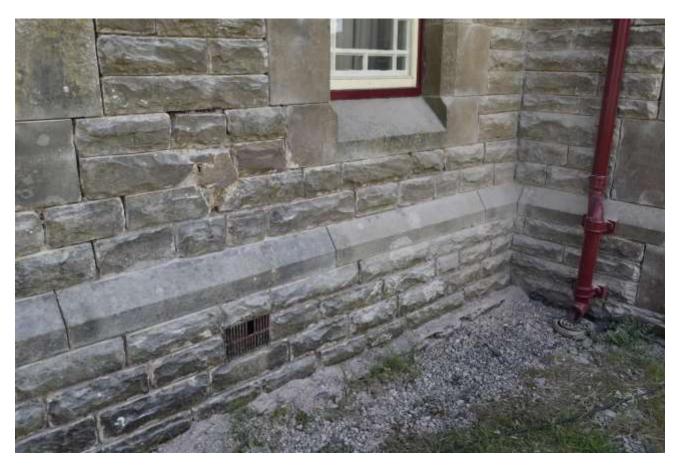
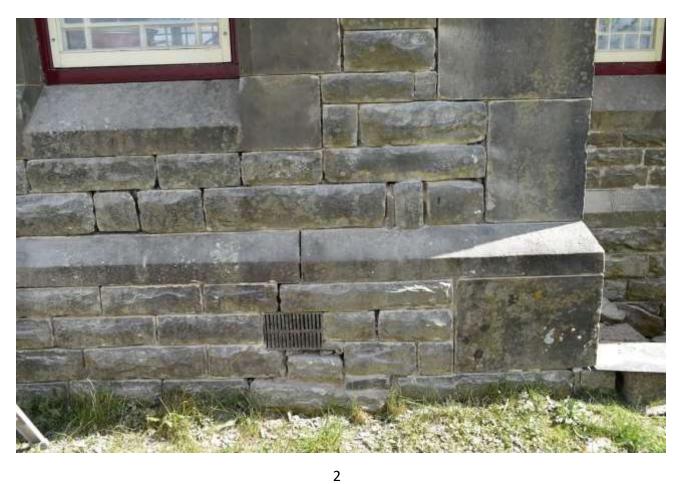
Joints raked out in preparation for pointing

Monday 15<sup>th</sup> May – Julian Wilkinson assisted by Seamus raking out low level joints to allow drying out to take place.

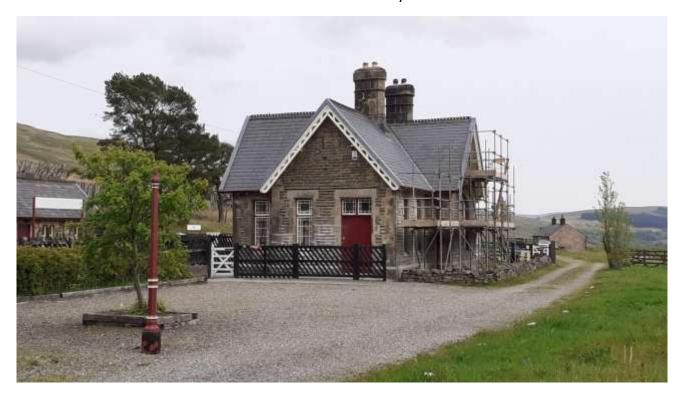
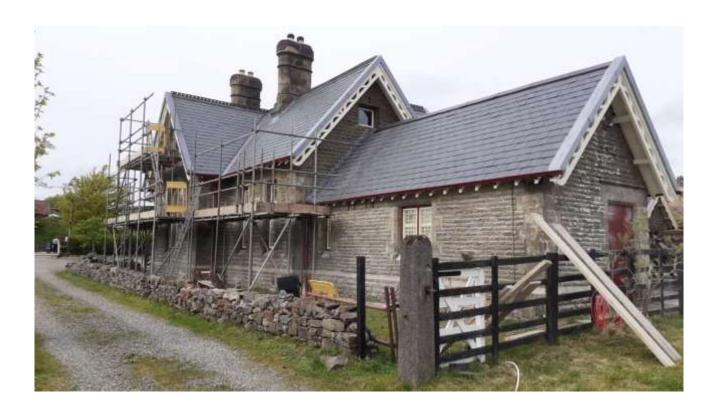
Scaffolding erected

Wednesday 17<sup>th</sup> May – raking out joints continuing. Scaffolding erected (Cumbria Scaffolding). Mortar collected from Eden Hot Lime. Julian now assisted by Seamus and Rob.

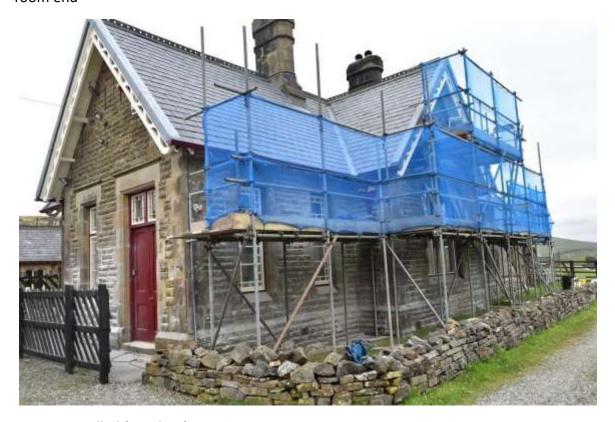
Netting installed (Cumbria)

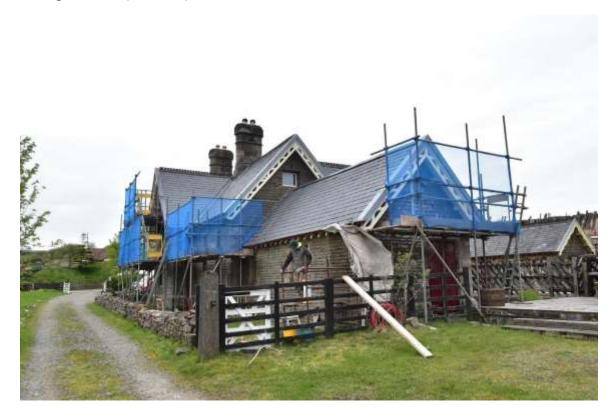
Scaffold to gable added (Cumbria)

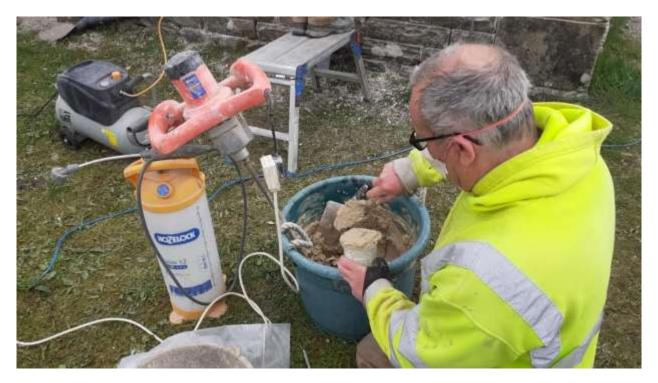
Julian mixing lime mortar

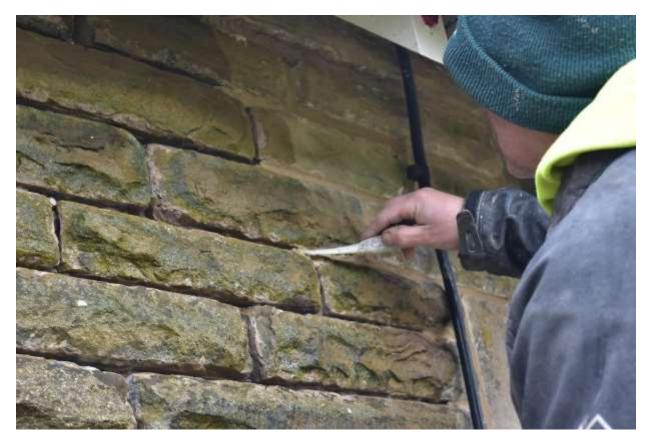
Lime mortar in progress

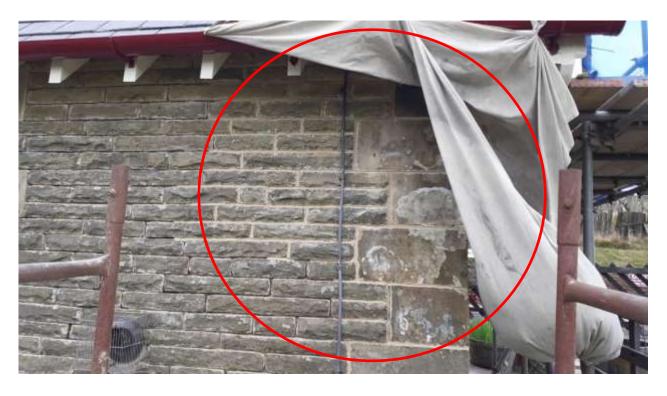
Completed section of mortar

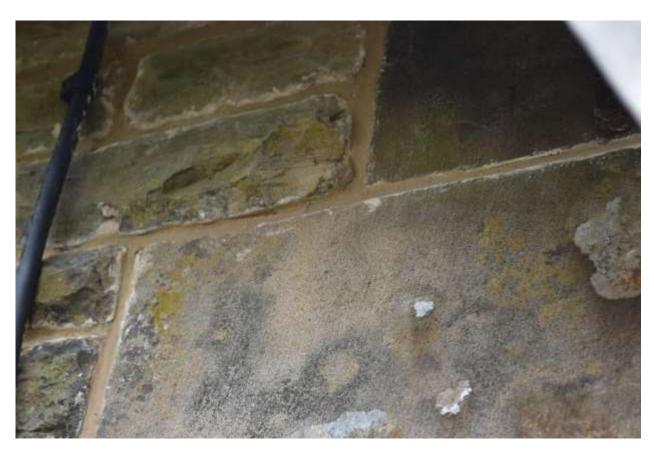
Monday 22<sup>nd</sup> May – pointing ongoing to w/c block (under hessian wrap)

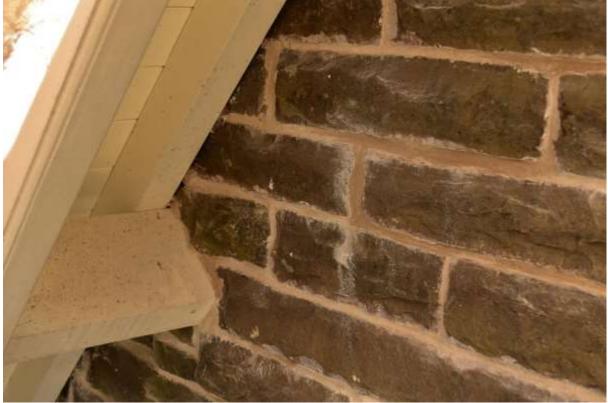
Apex to west gable

Wednesday 31<sup>st</sup> May: west gable projection peak complete; work ongoing on lower stage and return; curtain repairs ongoing (Kish) and sundry painting (John); fence and lamp standard repainted and attention to gate; work to grounds and hedges ongoing (Ken)

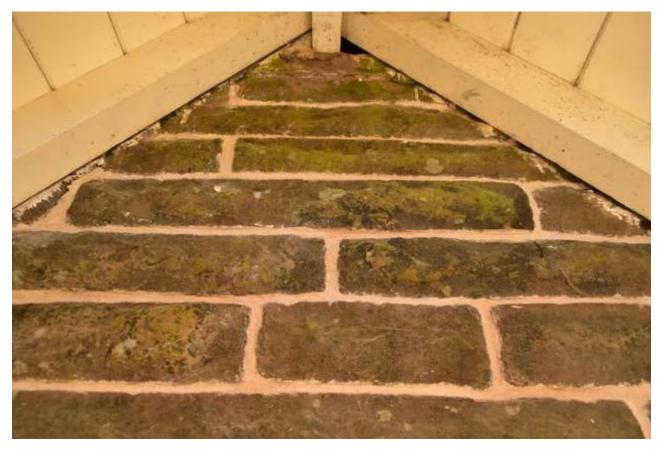
Apex to west gable

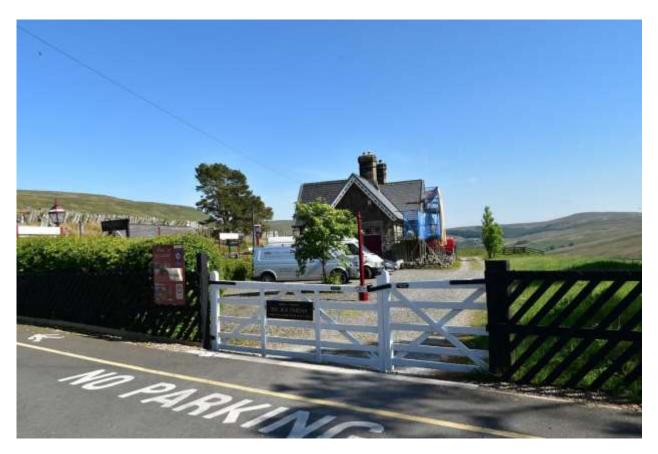
Fence and gates repainted

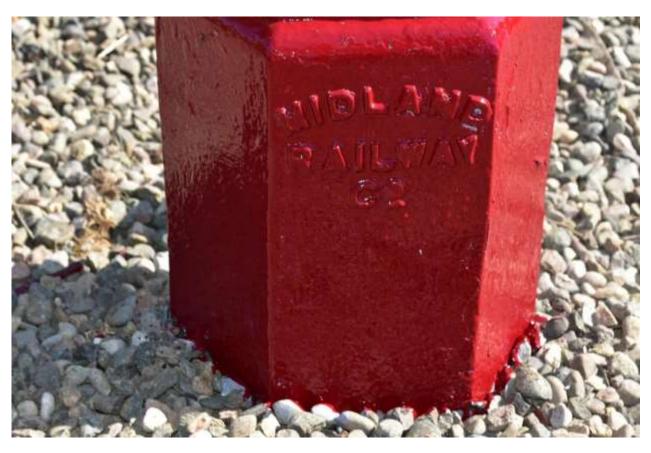
Midland lamp standard - new light fitting required

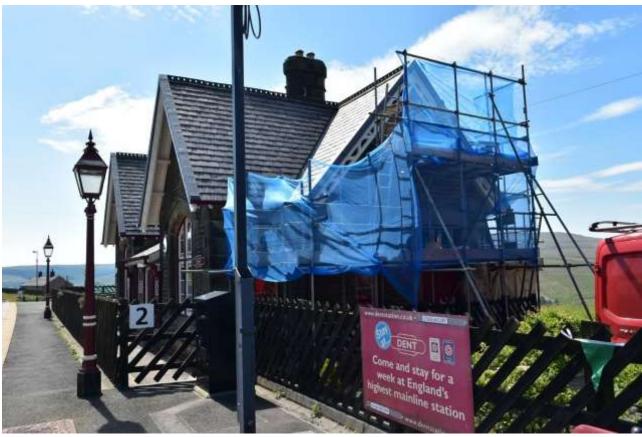
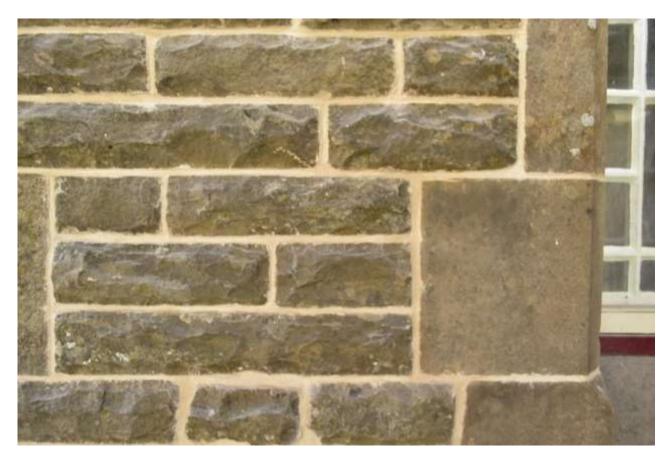
West elevation (both pictures)

Monday 12<sup>th</sup> June: west elevation completed; gable peak to boiler room ongoing; north elevation repointing ongoing at high level; Porters Doors now primed by Ken; sundry painting and grounds ongoing by Ken.

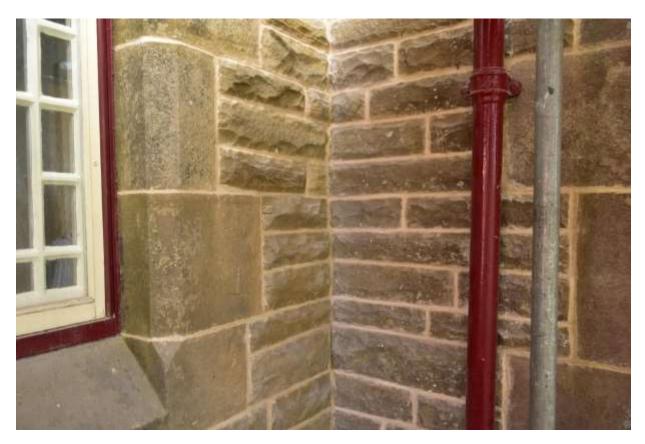
West elevation / west projection

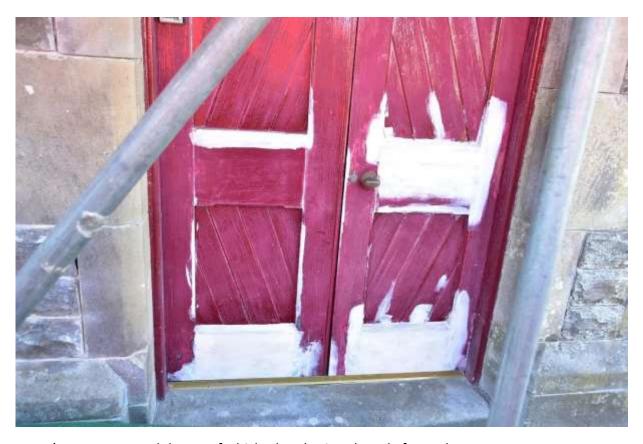
Porter's Room external doors refurbished and primed ready for undercoat.

Wednesday  $7^{th}$  June: Phil has refurbished and repositioned Porters Doors; scaffolding now erected on north gable elevation (Cumbria Scaffold)

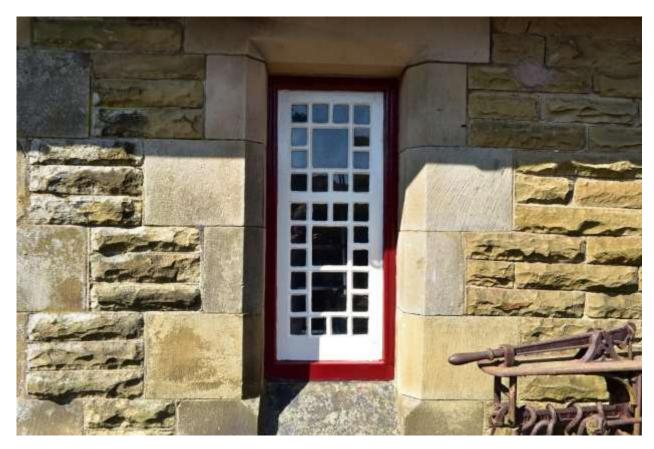
Boiler room window painted (Ken and John)

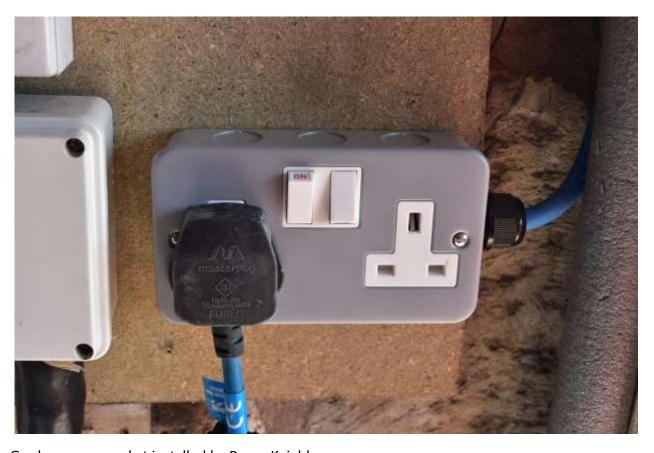
Garden power socket installed by Roger Keighley
